RE: San Miguel Electric Coop, Inc.
San Miguel Mine, Permit No. 11G
Final Action Notification, NOV 114A

Statement of Inspector's Observations
Notice of Violation No. 114A
Issued to San Miguel Electrical Cooperative, Inc.
San Miguel Mine, Permit No. 11G

COAL MINE INSPECTION REPORT

Inspectable Unit Name: San Miguel Area A&E Permit Number: 11G
 Permittee: San Miguel Electrical Cooperative Inc (SMECI) County: Atascosa and McMullen
 Industry Representative(s) Present: N/A
 Inspector: Jacob Eickstead Date of Inspection: March 17-18, 2015

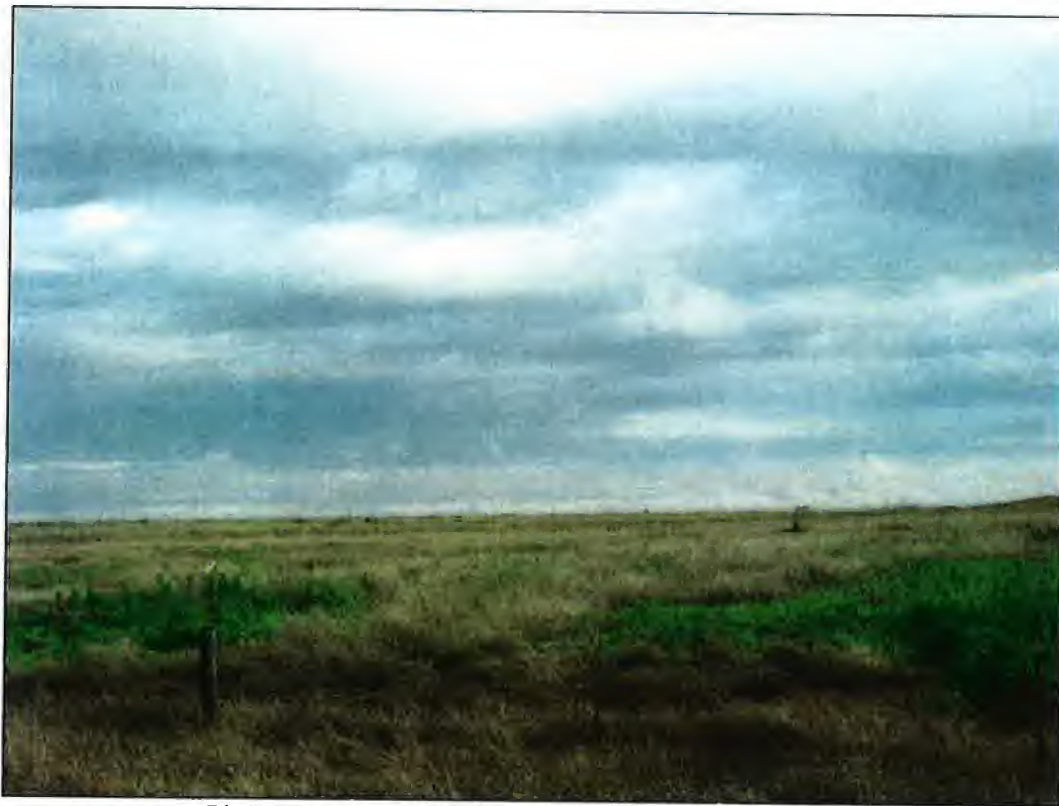
Vegetation has emerged from dormancy and is greening up on all areas of the mine (photo 1 and 2).

Photo 1. Typical vegetation in the A area (view south).

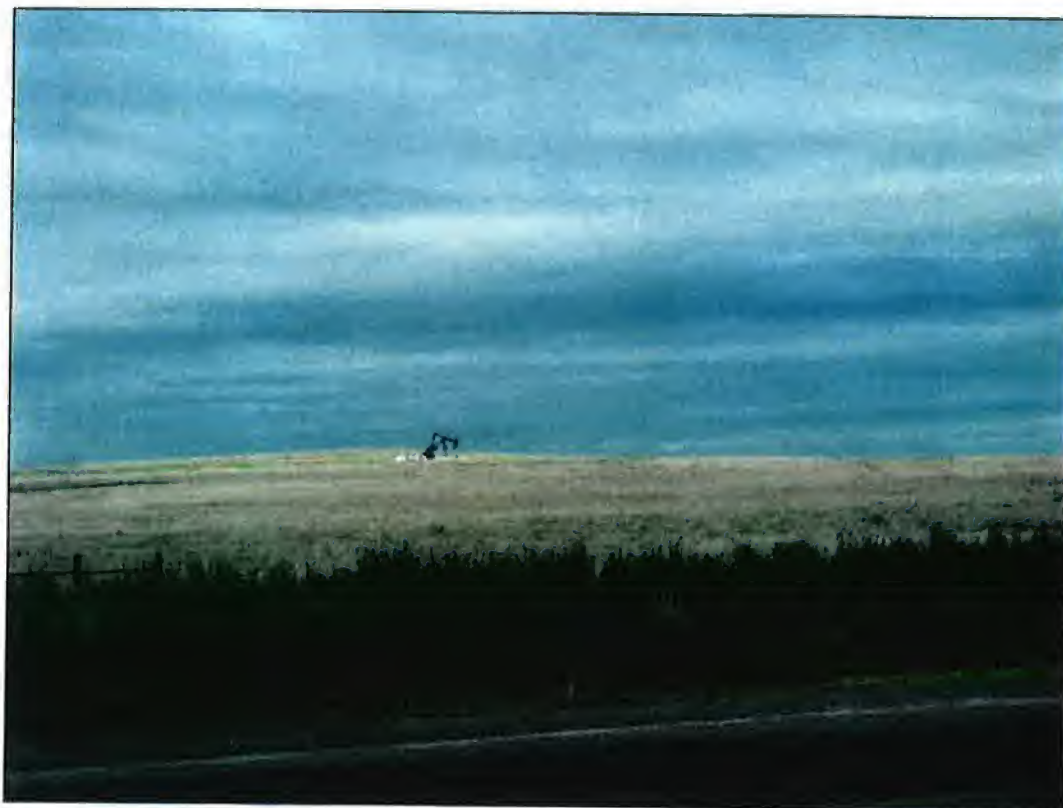
Photo 2. Typical vegetation in the E area (view northeast).

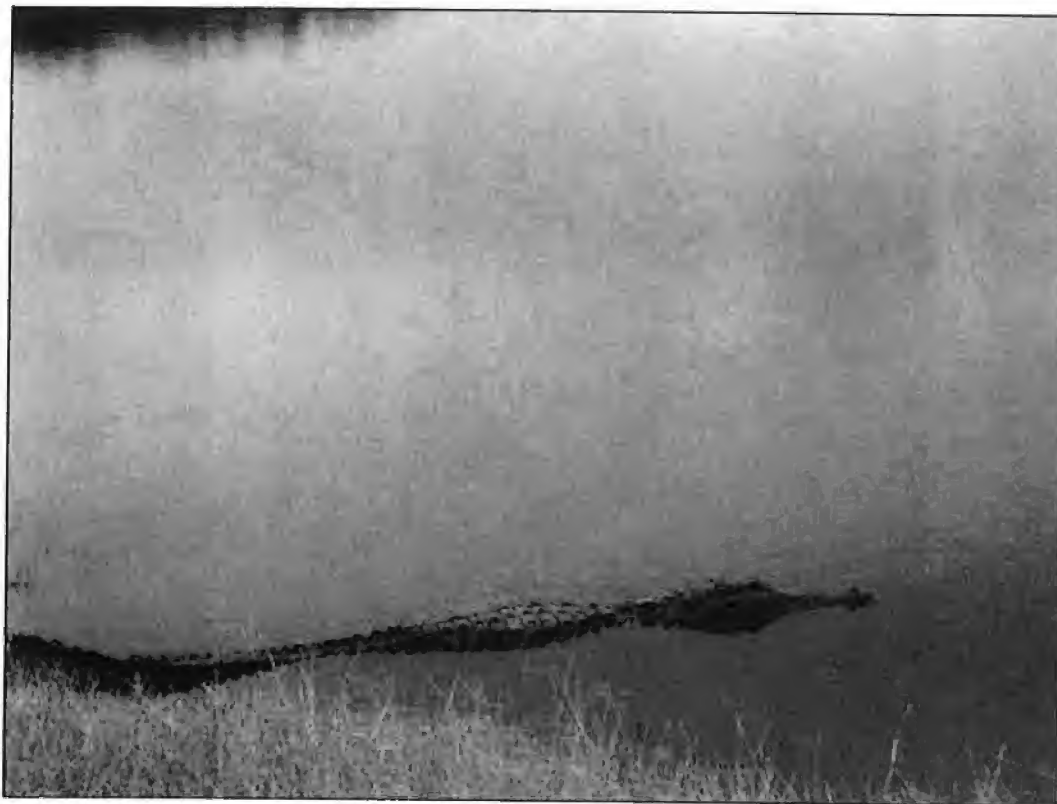
An alligator was observed in Pond G and an Upland Sandpiper was observed in the A area salt seep (photo 13 and 14).

Photo 13. Alligator in Pond G (view west).

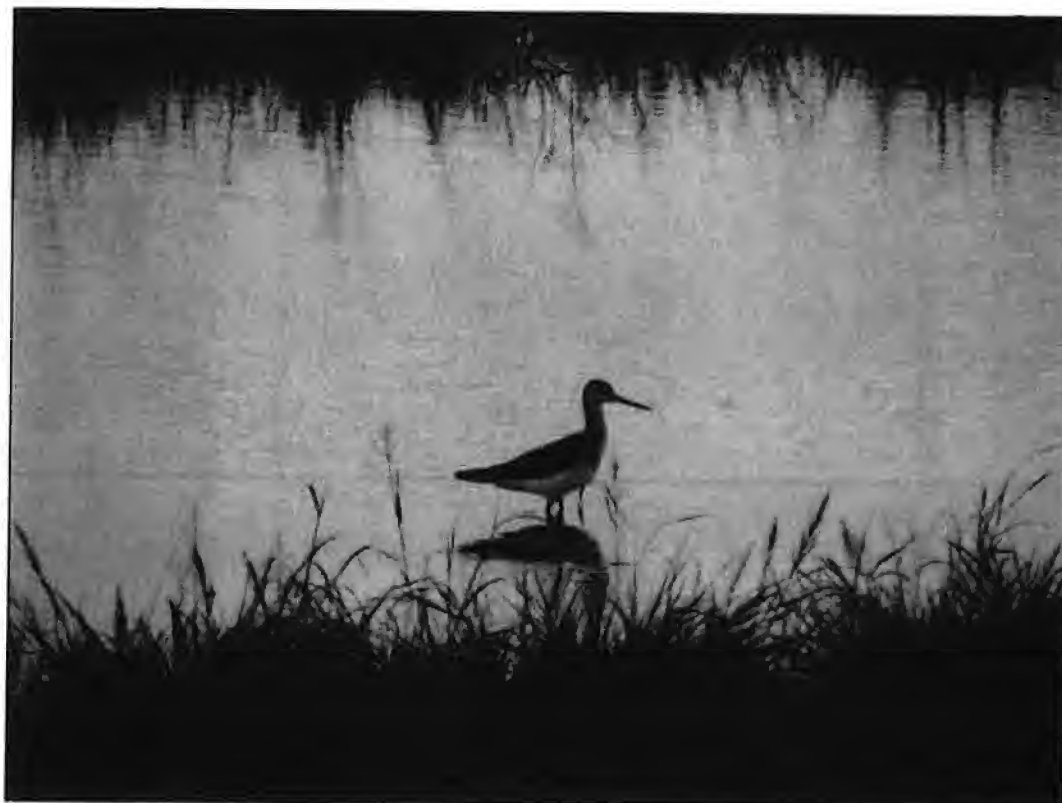
Photo 14. Upland Sandpiper (view south).
